# The Cases Where We Had To Bite The Bullet

Type of Publication: A Case Report

Guidewire fracture, though a rare complication can be encountered during percutaneous interventions. The importance of the retained guidewire in the coronaries points to fact that it can cause thrombosis, embolic events, perforation, dissection of vessel and vessel occlusion. The ways in which it can be managed, though there is no definite consensus on the same are, we can go for retrieval by snare or wire intertwining, use of second stent to crush the wire, balloon assisted fractured segment removal, open heart surgery and finally to proceed with conservative management with anticoagulation.

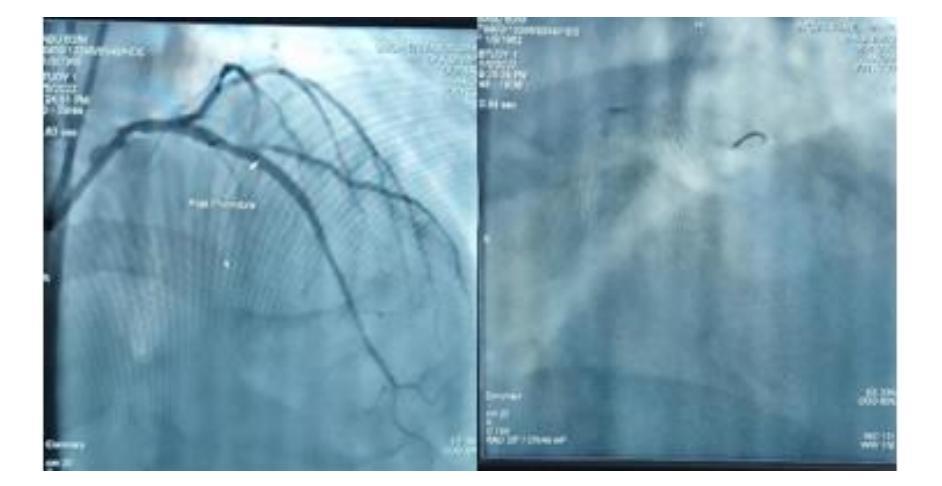
60 year old gentleman who presented with CAD ACS STEMI IWMI on 31.12.2021, Thrombolysed with Tenecteplase, later taken up elective angioplasty, showed LMCA with two vessel disease of RCA and LAD. Initially, d RCA was stented with 2.5 x28 DES, after OCT study, it was decided to stent from p LMCA to mid LAD. Considering the protection of major diagonal, balloon embedded technique was opted for LAD stenting, proximal LMCA to mid LAD stented 3.5 was with x48 DES. On attemptingrecrossing, the jailed wire got entangled in the stent struts, and got fractured, was hanging in the aortic sinus. Tried to remove the fractured wire segment with balloon assisted technique, but stent got

deformed. Thereupon, a shared decision was made in consultation with cardiovascular surgeons to proceed with conservative management as there was no chest pain, no ECG changes and no enzyme elevation. He was started on anticoagulation. On follow up after 2 years now, he is asymptomatic and continuing anticoagulation.

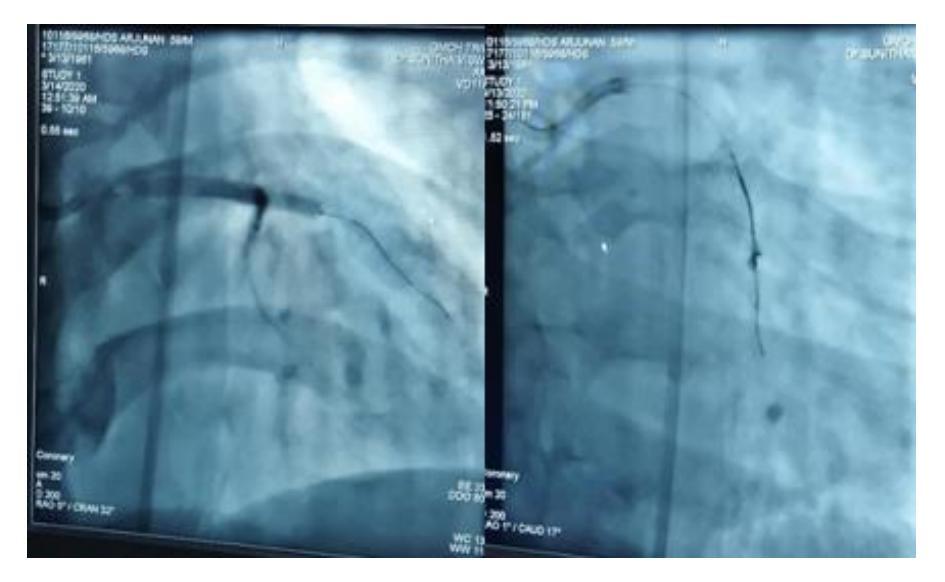
59 year old gentleman, case of CAD ACS STEMI IWMI on24-11-2018 underwent thrombolysis, subsequently had exertional angina FCII, was taken up for Coronary Angiogram which showed distal LCX chronic total occlusion, JCTO 2 with rentrope II Collaterals. Theleision was crossed with GAIA 2 with microcather support, and wire was exchanged for versaturn and placed in distal OM3, Another, versaturn wire was used to wire OM2. The distal LCX to OM3 was stented with 2.5 X 19 DES. On attempted removal of jailed wire from OM2, it got entangled and fractured. Attempted removal of the balloon technique, wire using caused stent deformation. Post dilation of the stent and attempts for

both wires came out, jailed wire broke and its free edge was found floating in aortic sinus. Check injection showed guide induced dissection of pLAD extending to mid LMCA, patient developed cardiac arrest, resuscitation started ,guide was disengaged and cannulated with 7 F JL 4 , crossed with Fielder FC and opLMCA and p LAD was stented with 3.5 x38 DES, hence further attempts to remove the fracture wire was abandoned and decided to proceed with conservative management. We gave the option of open heart surgery to relatives , but deferred and he was started on anticoagulation. Hebecame clinically betterlater, and he was discharged in stable condition.

removal of fractured wire failed. On further pulling
